Ice Engineering

Ice Jams in New Hampshire

This *Ice Engineering Information Exchange Bulletin* provides a brief summary of ice event data within New Hampshire that is contained in the CRREL Ice Jam Database. This is the third in a series that will characterize every state affected by ice jams using the CRREL Ice Jam Database.

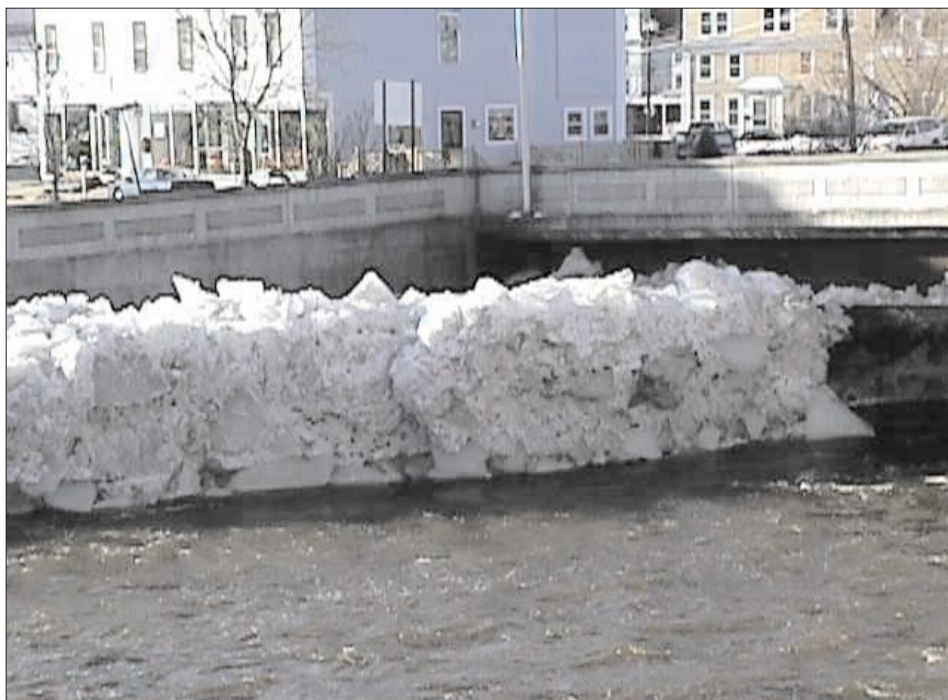
Figure 1. Shear wall left behind following failure of the January 1999 ice jam on the Israel River in Lancaster, New Hampshire. Note ice on low steel of bridge. (Photograph courtesy of www.greatnorthwoods.org.)

An ice jam is an accumulation of ice in a river that restricts water flow and may cause backwater that floods low-lying areas upstream from the jam. Areas below the ice jam can also be affected when the jam releases, sending water and ice downstream. Damages resulting from ice jams can affect homes, buildings, roads, and riverine structures; block hydropower and water supply intakes; and decrease downstream discharge (Fig. 1).

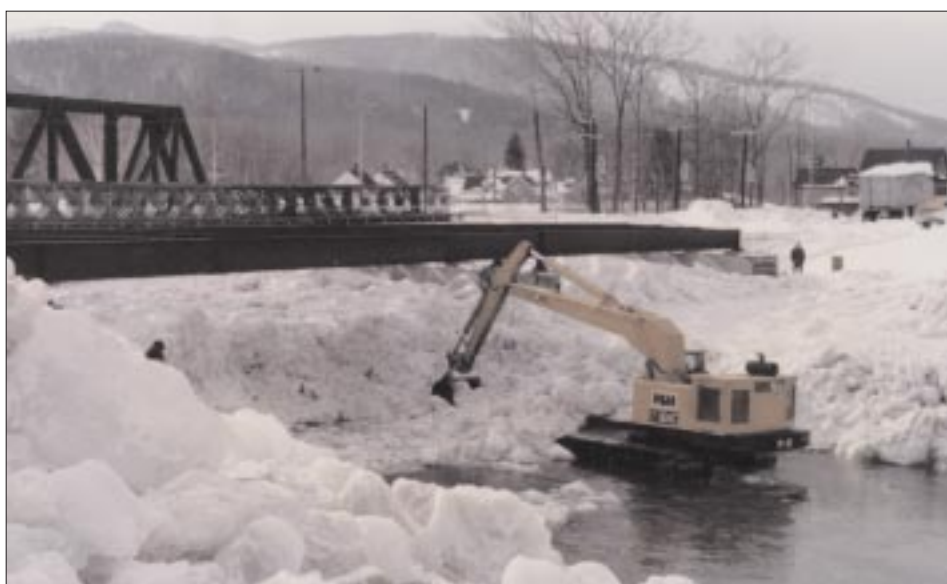
Figure 7. Backhoe clearing channel in Peabody River, Gorham, New Hampshire, February 1982. (Photograph by Dan Ayer.)

It took a bulldozer, backhoe, loader, and wood skidder 15 days to cut a 2,500-foot-long channel approximately 50 to 100 feet wide and 10 to 15 feet deep to alleviate the flooding. The bulldozer and backhoe did the majority of work from their own ice roads, which were constructed as they went along (Fig. 7). Total project cost was \$17.8K (1982 USD).

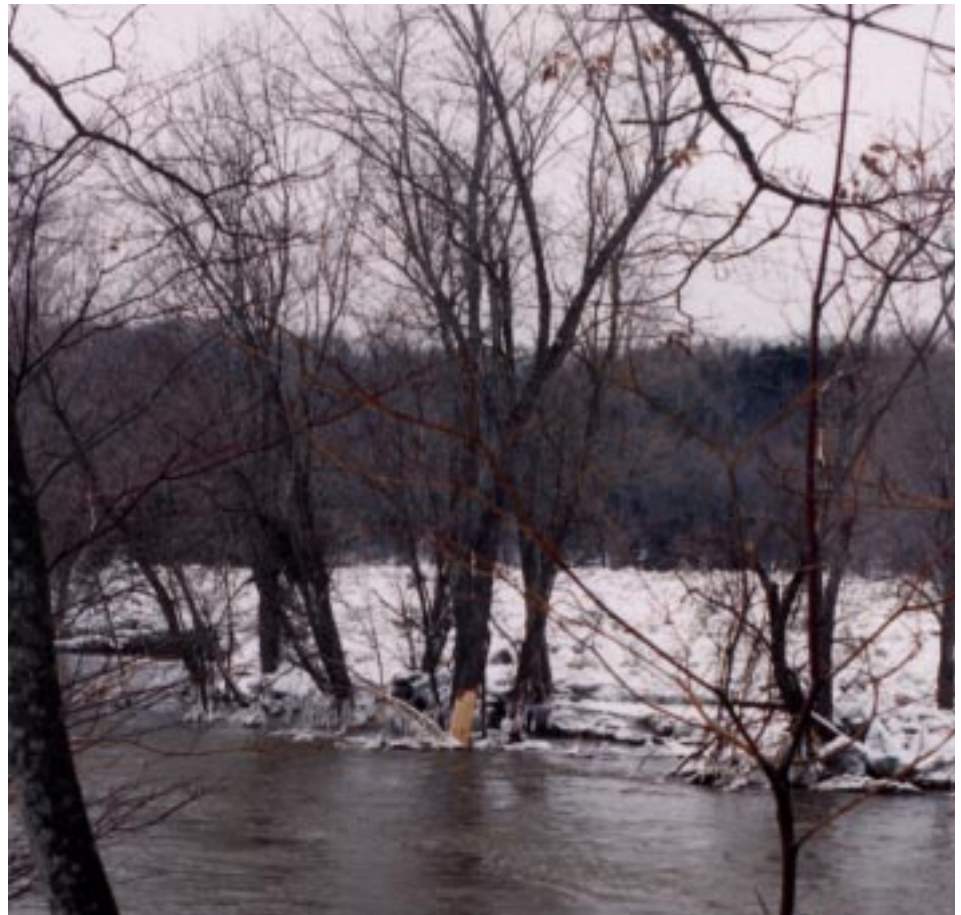
Figure 8. Wild Ammonoosuc River between Lisbon and Bath. Note ice in the floodplain and tree scar caused by ice. (Photograph by Kate White.)

As is true for the database as a whole, many of the sources relied upon for information on ice jams in New Hampshire lack quantitative data on damages. However, 82 (16%) of the New Hampshire ice jam events in the database have known damages, a much higher percentage than for the whole database (about 2%). The most common damages include bridge, commercial, and residential damage, road and railroad flooding, evacuations, and agricultural damages. Figure 8 shows an ice-covered floodplain and an ice-damaged tree.
